## HPFAA Proof of Loss–Summars/Forest

## SIGNIFICANT COMPENSATION FOR LOSS OF FORESTLAND IS REQUIRED

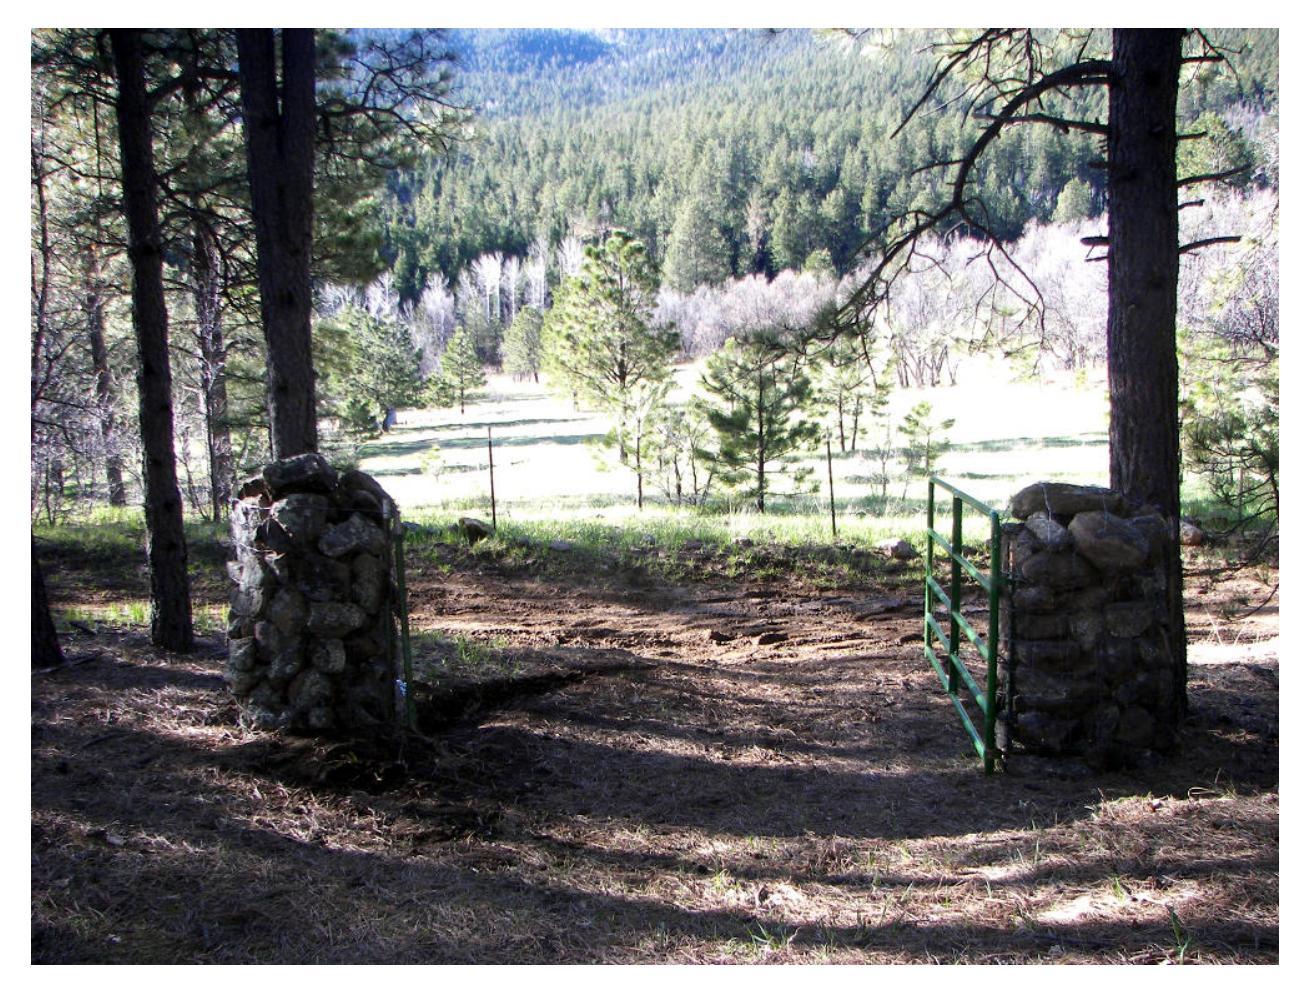
View from the north tract access gate at county road A042 across the meadowland of the south tract.

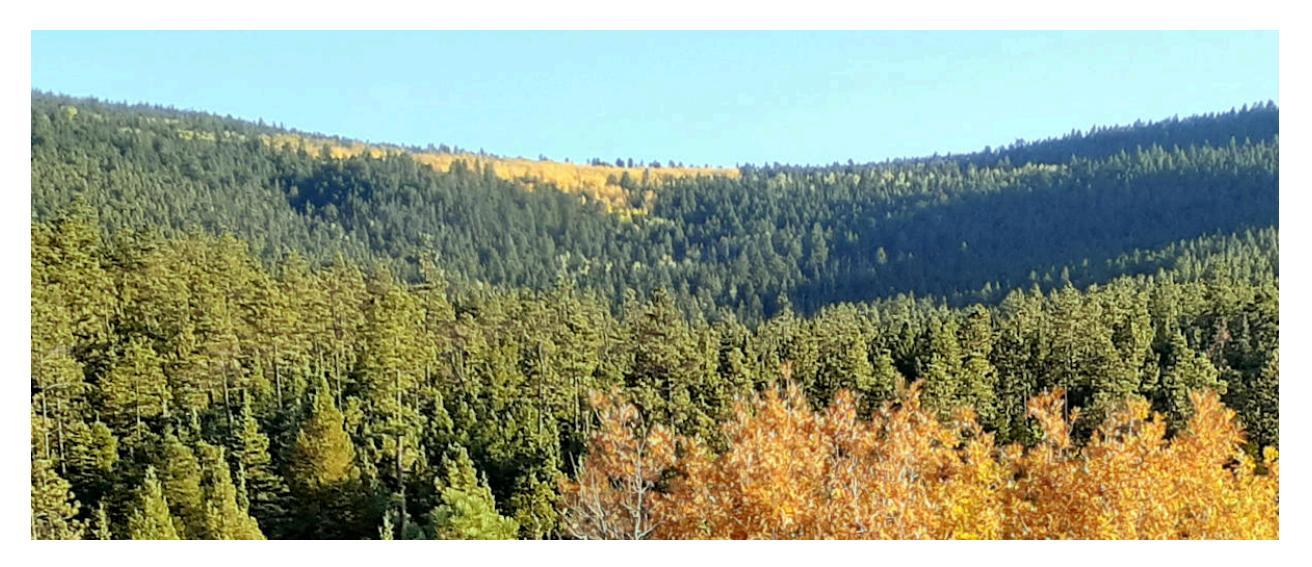
Forestland up the north-facing slope of the south tract was growing dense on steep terrain.

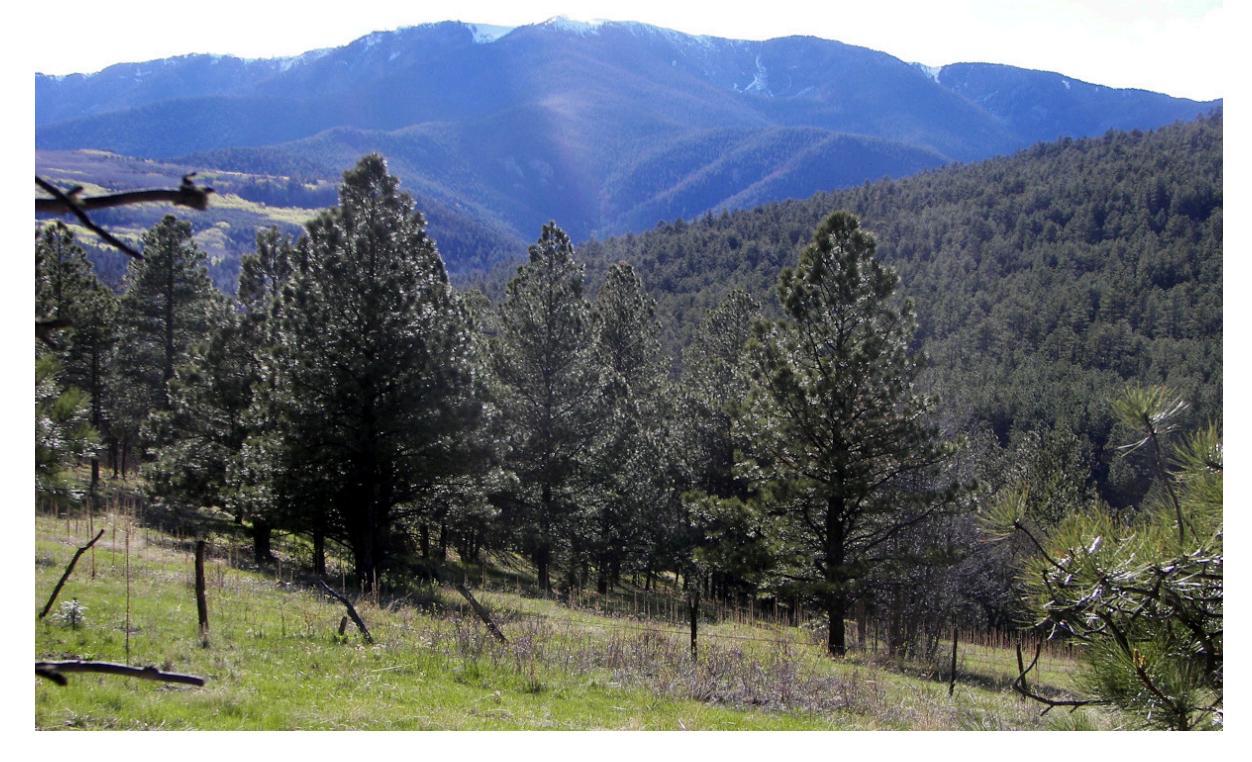
The Rito Garcia drainage extends up slope more than 4 miles west of the parcel into steep terrain.

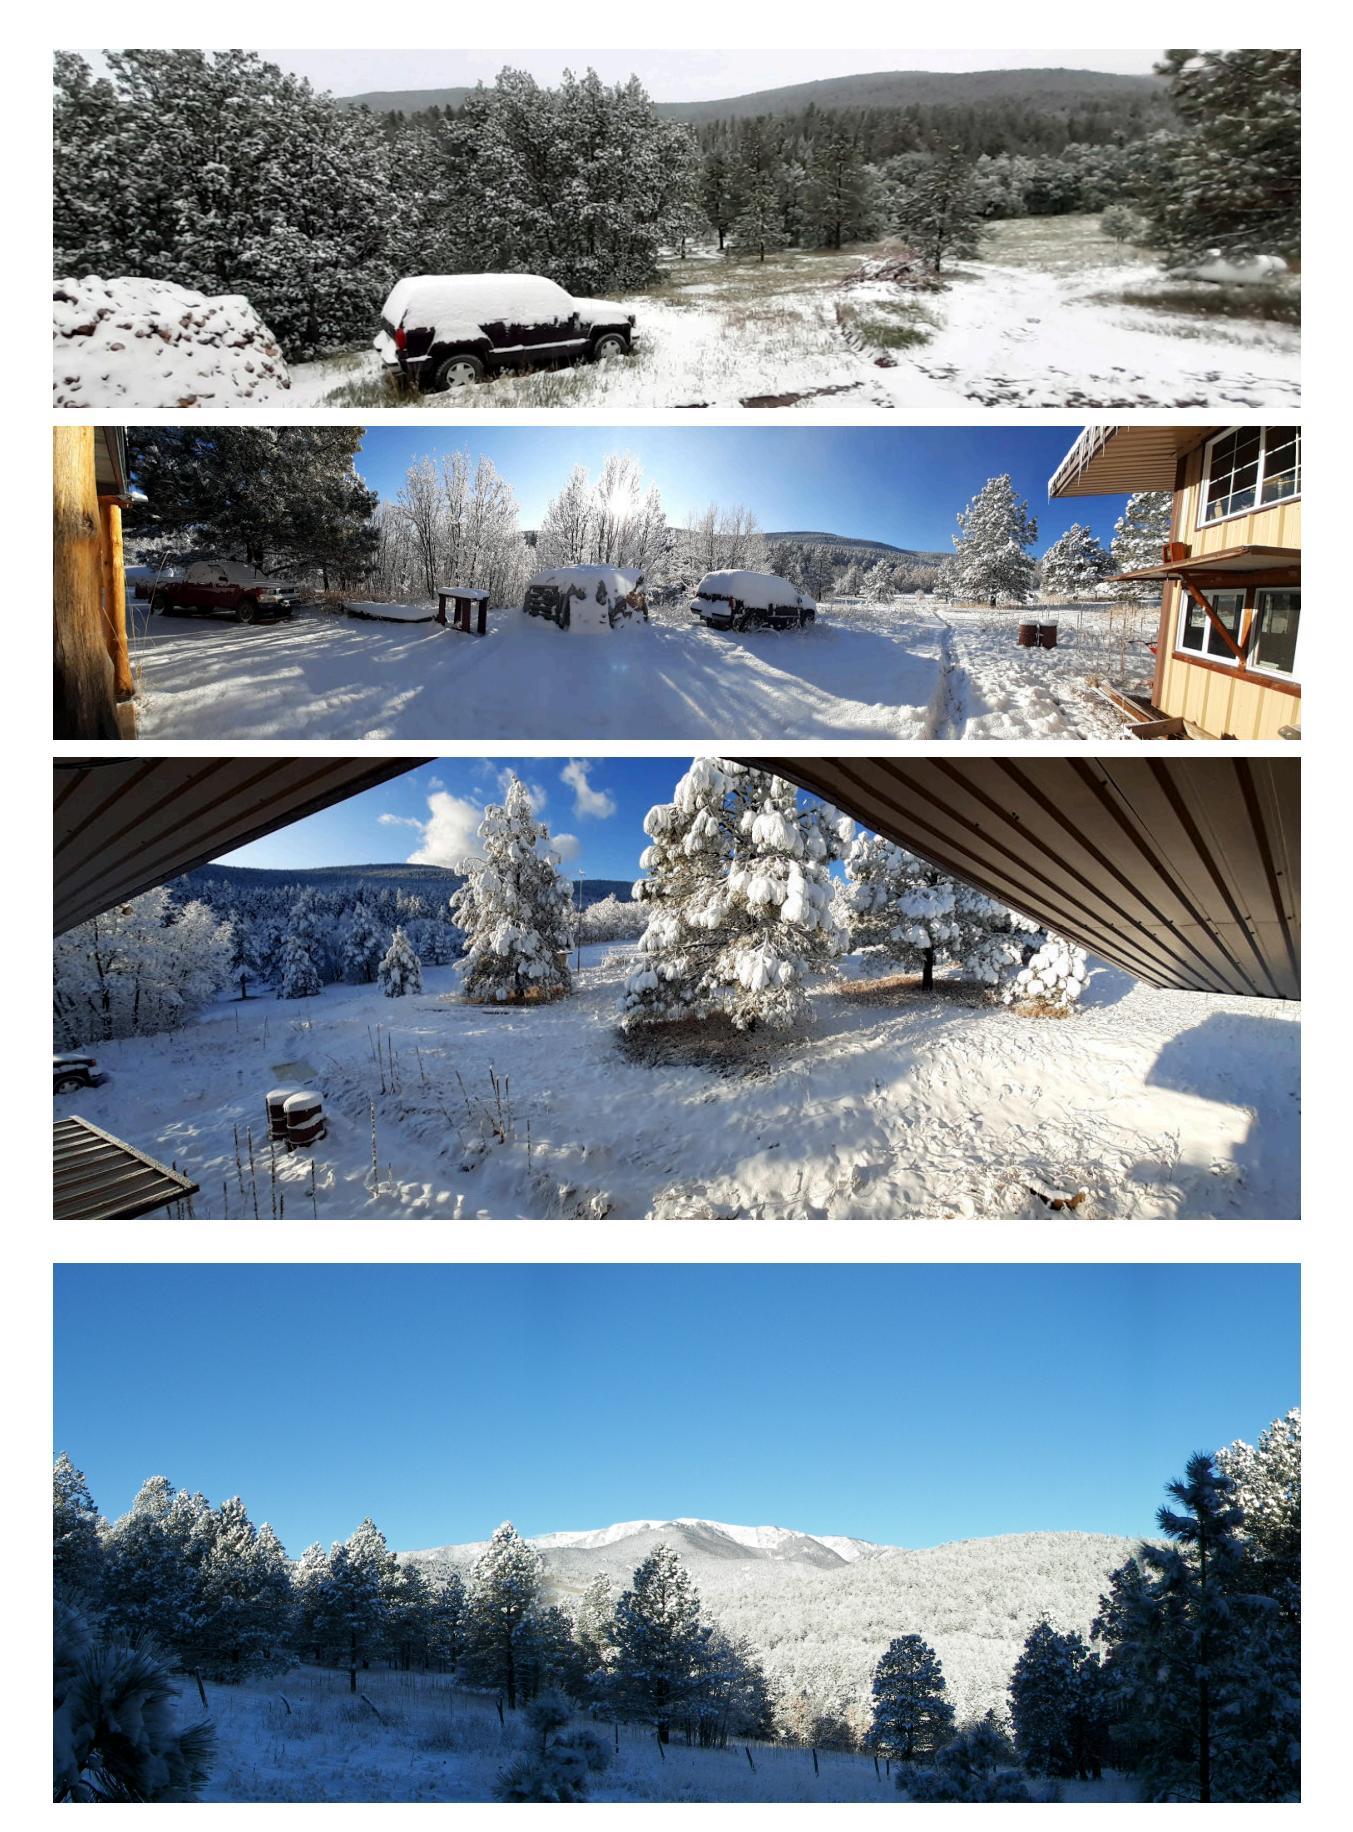
Considerable amounts of precipitation can fall in the Rito Garcia drainage in a short amount of time.

Threat of large debris flows from the west (from the left in the Google Earth aerial image below) is significant due to extensive burn scar on both sides along the up slope length of the Rito Garcia drainage. Debris flows are practically guaranteed to come from that direction during future severe rain storms.

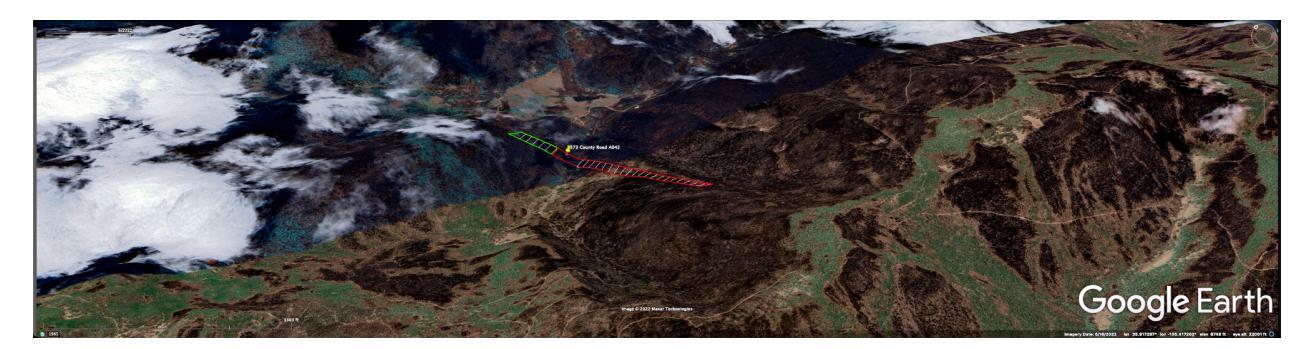
Shape of my homestead property's terrain and all terrain surrounding it are extremely conducive to land and mud slides, and to debris flow incidents. Burn scars in every direction are too extensive and the soil in those burn scars too severley scorched to apply thorough, effective debris flow mitigations measures in any reasonable amount of time. And even after such measures may or may not be implemented, they will never be thorough enough. The only direction debris flows may not occur to affect areas within the boundary of the homestead property is the easterly direction, down hill from the property.

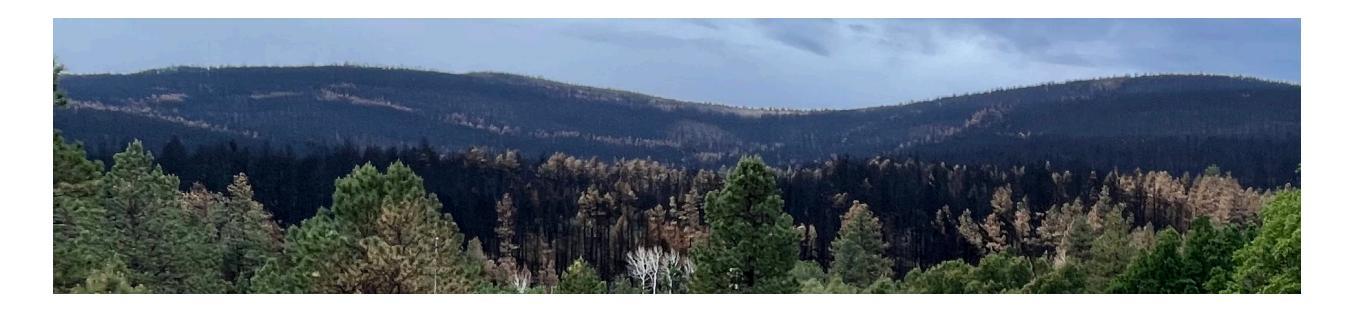
The south tract across its entire width, from the far side of Rito Garcia all the way up to the south property boundary where it abuts the Santa Fe National Forest, up slope through the national forest to the ridge, and over that into and beyond the valley on the other side is charred, dead trees and scorched soil. Likelihood for landslide, mudslide and debris flow from that direction along the entire length of the north-facing slope is significantly high. The dark forestland up to the ridge in the photo below is totally burned.

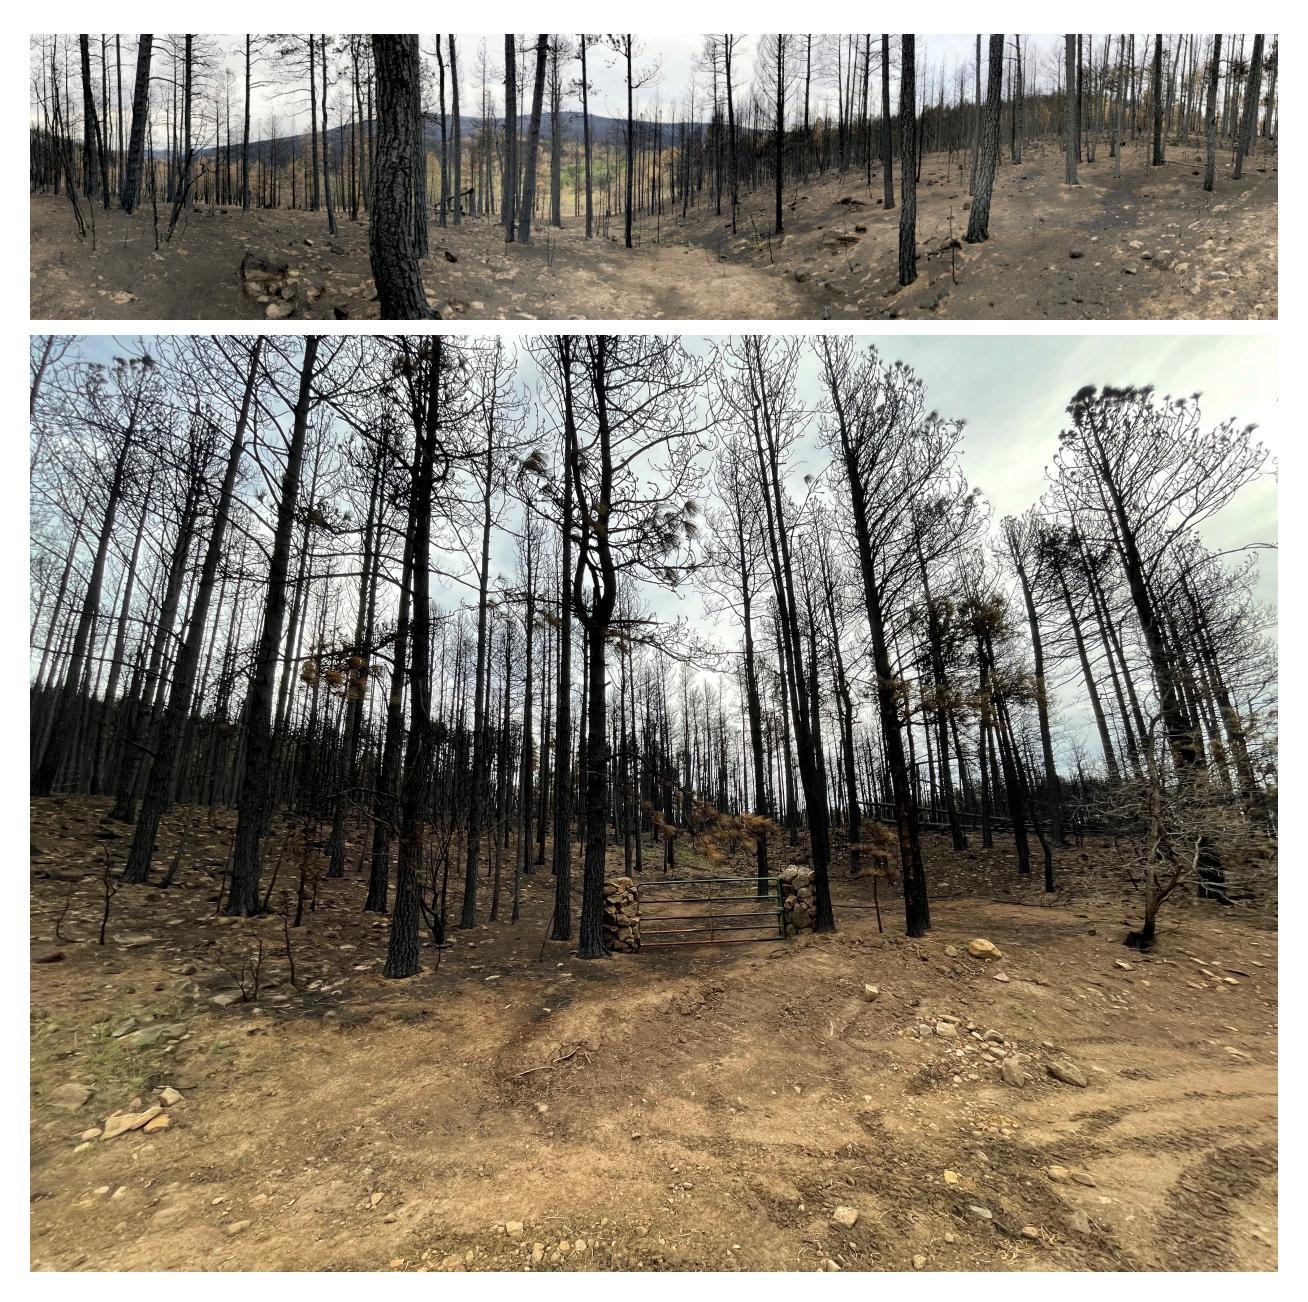
The north tract is in the same condition up that south-facing slope. Nothing but dead trees and scorched soil over its entire area. Landslide, mudslide and debris flow potential poses unacceptable risk to the entire meadow area of the south tract from the county road down to the north bank of Rito Garcia. There is no location anywhere on the property stable enough now to rebuild the homestead.

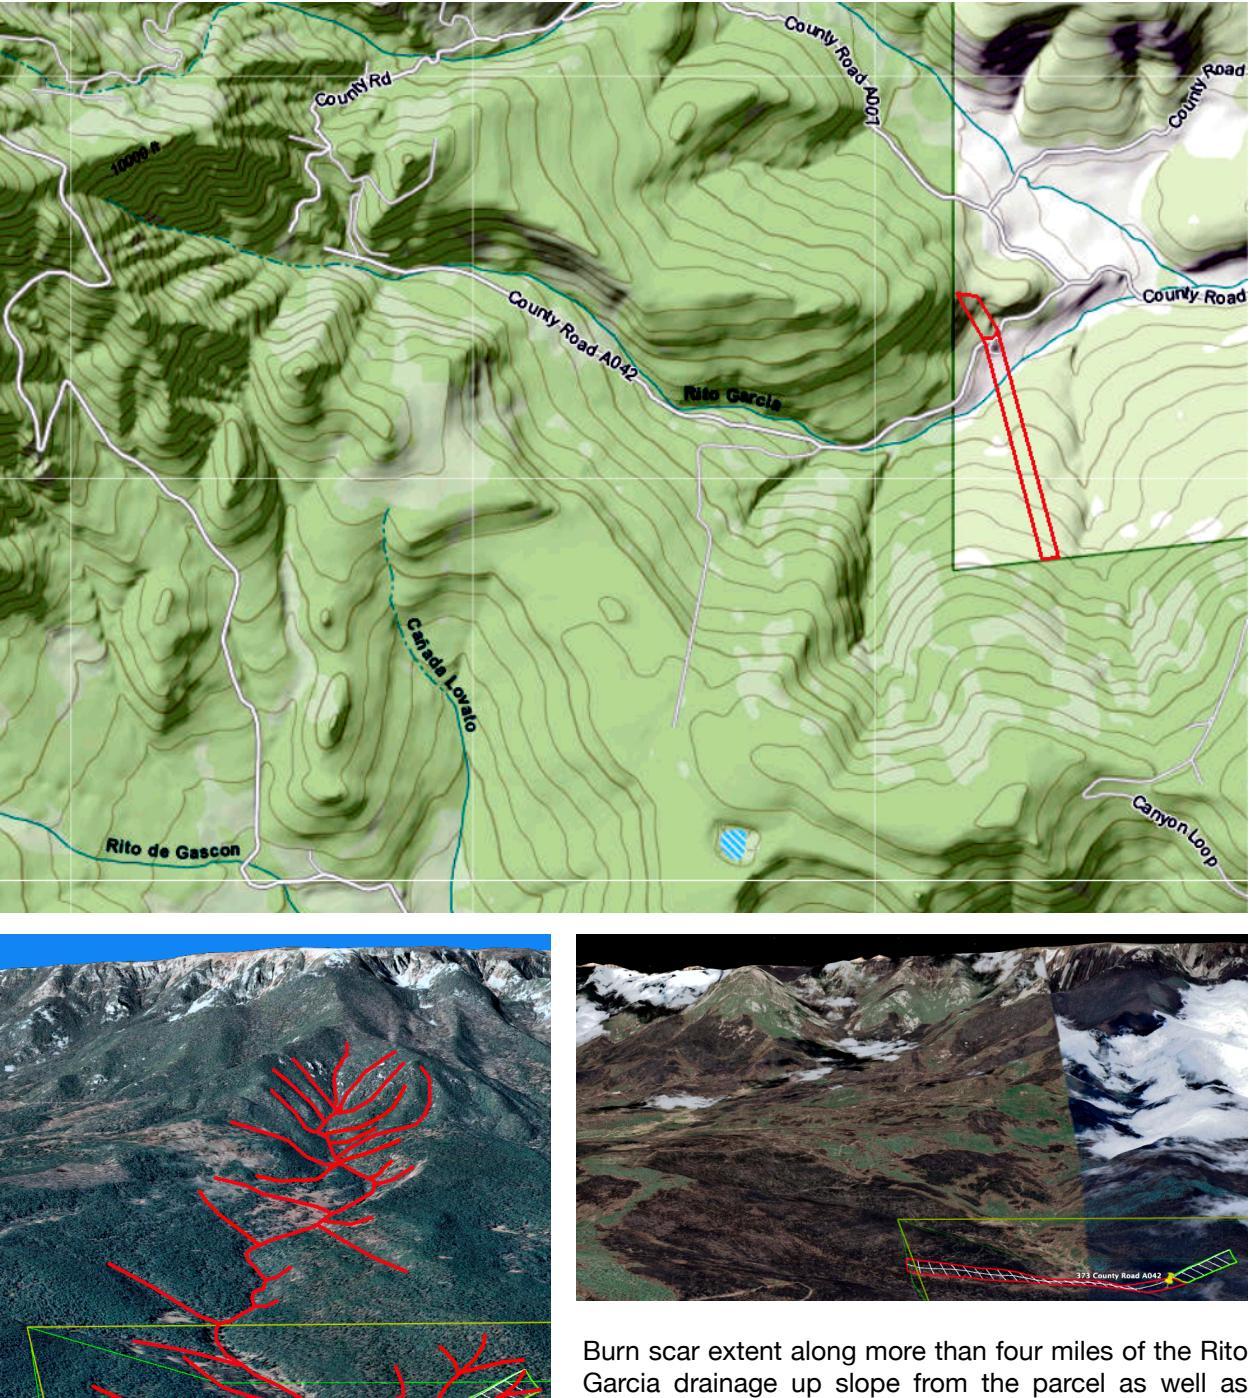
Topographical information available for the parcel and surrounding region clearly show high risk drainage slopes to the north, west and south. More than four (4) miles of steep, constricted drainage slopes along both sides of the length of Rito Garcia from its headwaters to the parcel boundaries were severely burned by the wildfire.

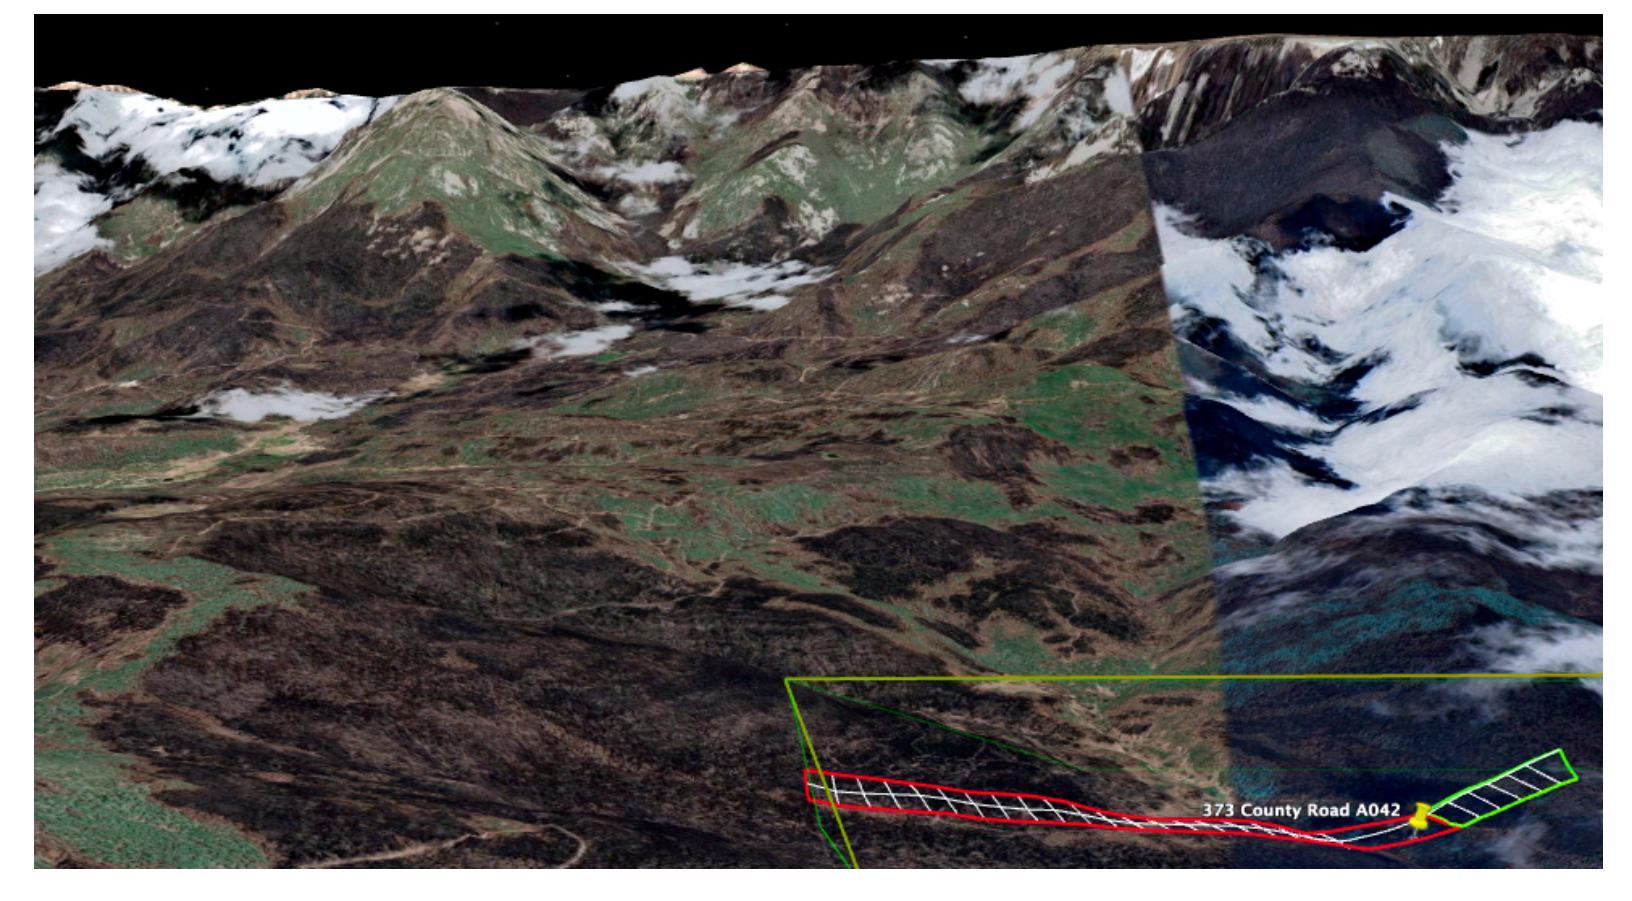
Burn scar extent along more than four miles of the Rito Garcia drainage up slope from the parcel as well as burn scars on and surrounding the parcel's north and south slopes are severe. Flooding and debris flow risk are now significantly more extreme during heavy rains.

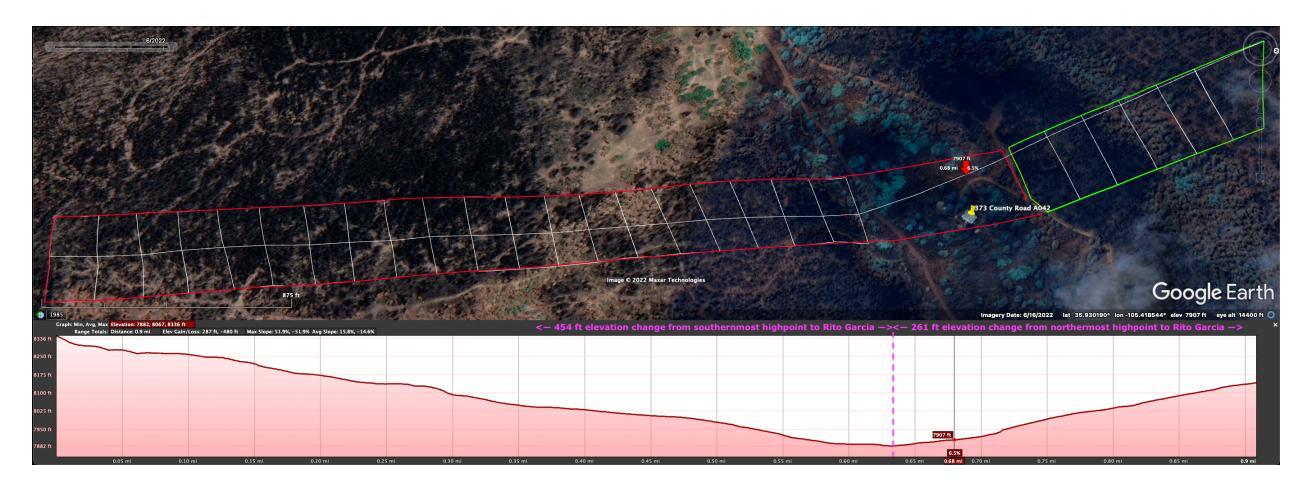
The parcel is just under one mile in length with average slopes exceeding 14% on each tract from highest points north (right) and south (left) down to lowest point at Rito Garcia (at the dotted vertical line):

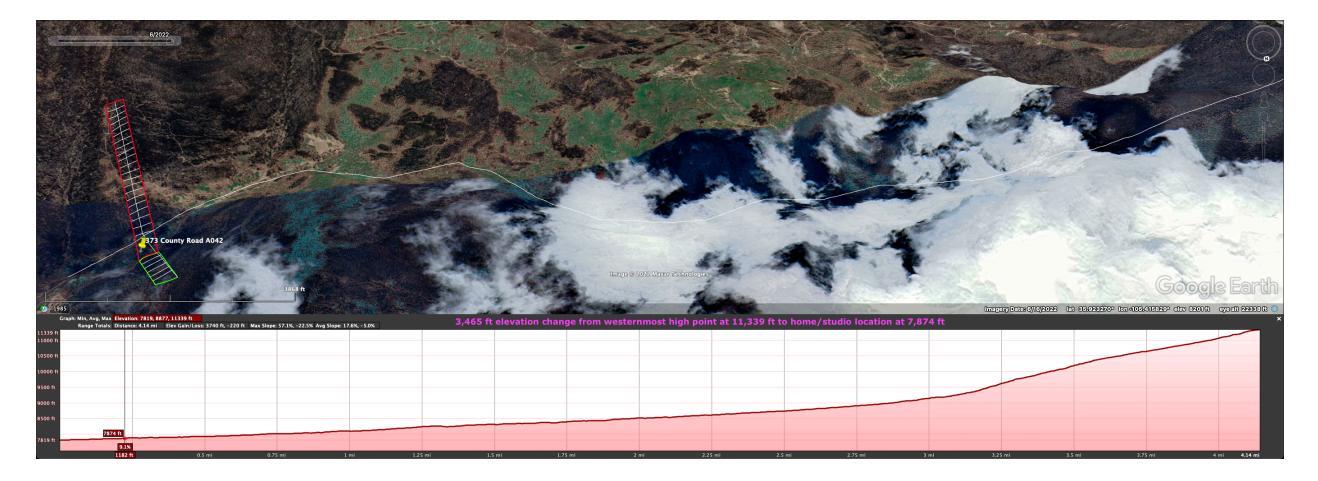
Rito Garcia runs more than 4 miles from its highest point west (right) to the place it intersects with the west boundary of the parcel. Average slope over that distance is more than 17% with extensive burn scar damage along both sides of the water course:
